**LABORATORY MEASUREMENT OF
THE REDUCTION OF
TRANSMITTED IMPACT SOUND OF
PINNACLE ECO-COMFORT
UNDERLAY**

AUCKLAND UNISERVICES LIMITED
a wholly owned company of
THE UNIVERSITY OF AUCKLAND

Report prepared for:
Pinnacle Underlay Ltd.
P O Box 10105
Rotorua

Date: 18th December 2009

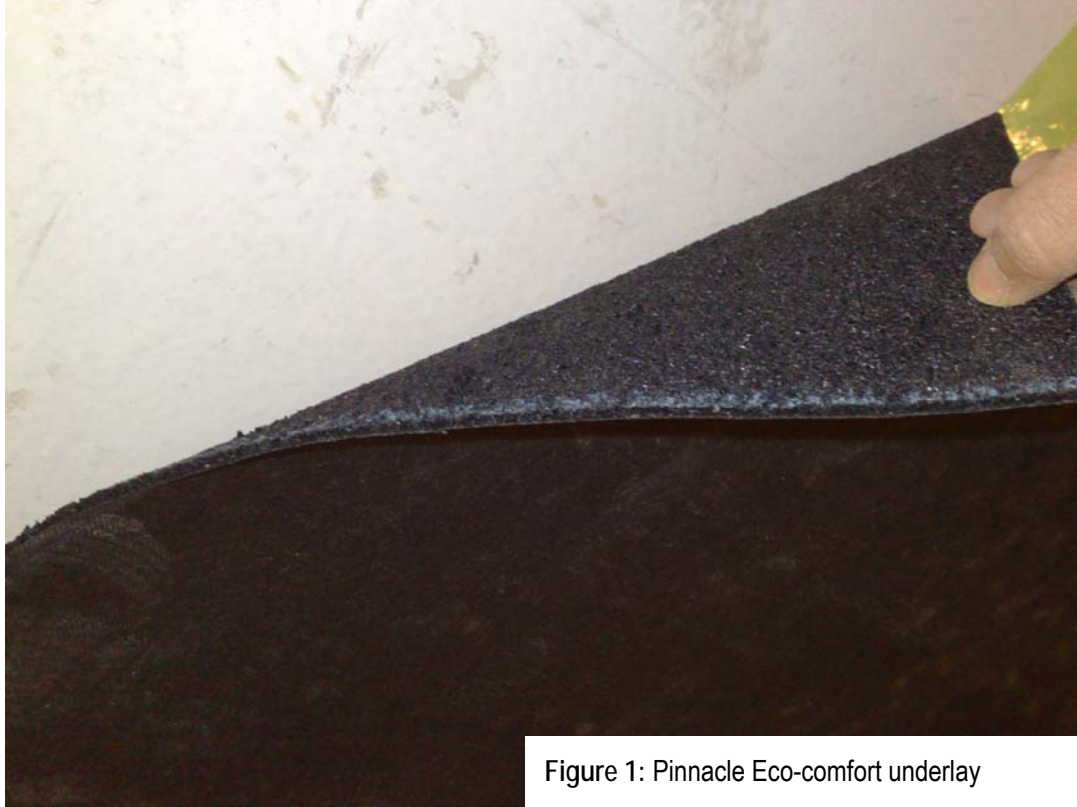
Pinnacle Eco-Comfort underlay adhered to the test floor slab with *Green Solutions 300 (GS300)* acrylic waterbased adhesive applied with a 1.5mm notched trowel.

Figure 1: Pinnacle Eco-comfort underlay
